**Degradation of Peel and Tensile
Strength of Bonded Panels
Exposed to High Humidity**

DSTO-TR-1272

**Airframes and Engines Division
Aeronautical and Maritime Research Laboratory**

November 2001

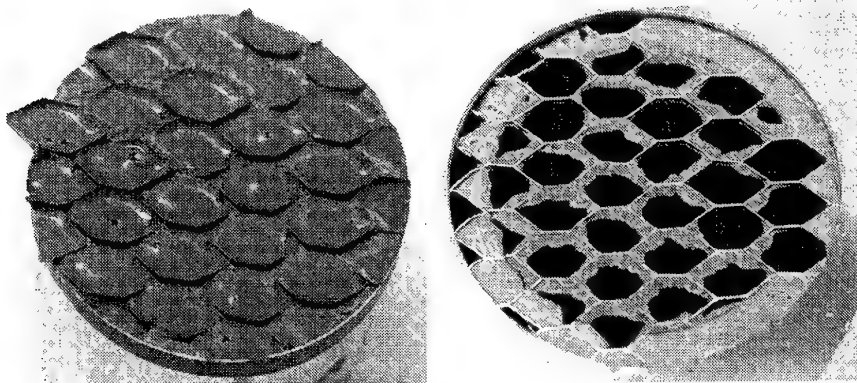
Figure 3 Failure surfaces resulting from tensile testing of the Dura-Core honeycomb and JD Lincoln adhesive control specimen, indicating a mixture of cohesive failure and fillet bond pull-out.

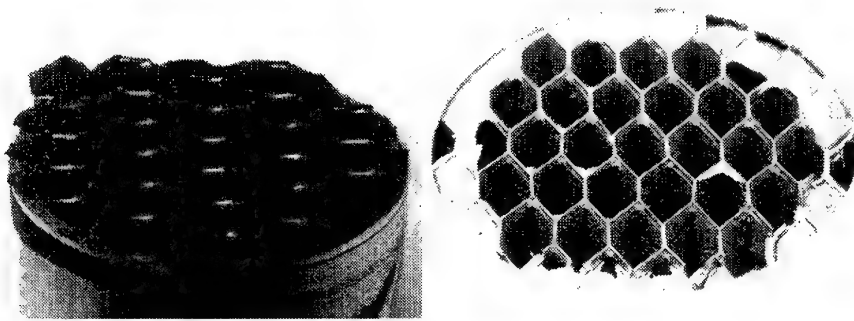
Figure 4 Failure surfaces resulting from tensile testing of the Dura-Core honeycomb and JD Lincoln adhesive conditioned 30 days at 70°C/100% R.H., indicating fillet bond pull-out.

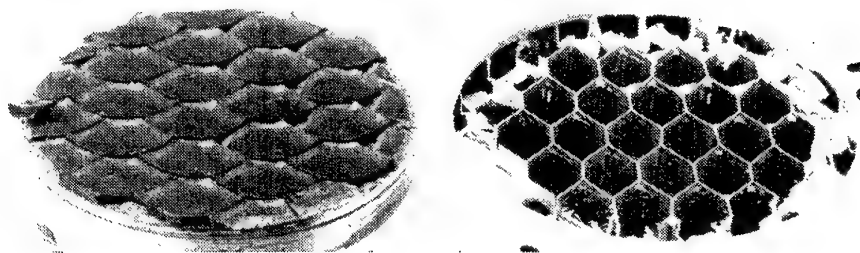
Figure 5 Failure surfaces resulting from tensile testing of the Dura-Core honeycomb and JD Lincoln adhesive conditioned 150 days at 70°C/100% R.H., indicating fillet bond pull-out.

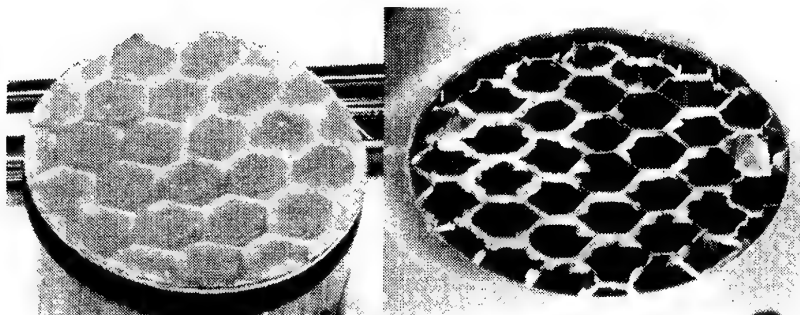
Figure 6 Failure surfaces resulting from tensile testing of the Untreated honeycomb and AF130-2 adhesive control specimen, indicating a mixture of cohesive failure and fillet bond pull-out.

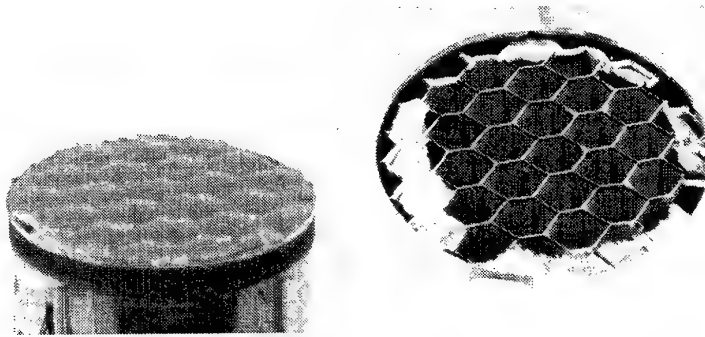
Figure 7 Failure surfaces resulting from tensile testing of the Untreated honeycomb and AF130-2 adhesive conditioned 30 days at 70°C/100%R.H., indicating fillet bond pull-out.

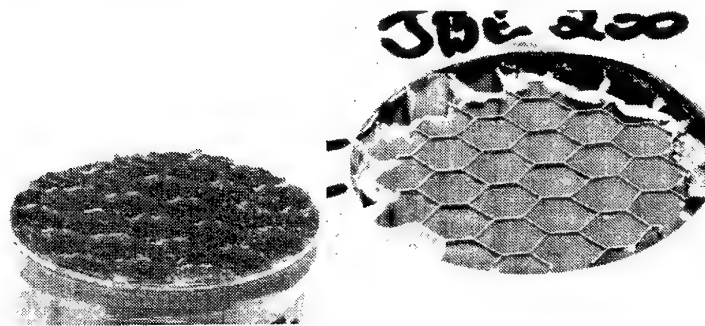
Figure 8 Failure surfaces resulting from tensile testing of the Untreated honeycomb and AF130-2 adhesive conditioned 150 days at 70°C/100%R.H., indicating fillet bond pull-out.

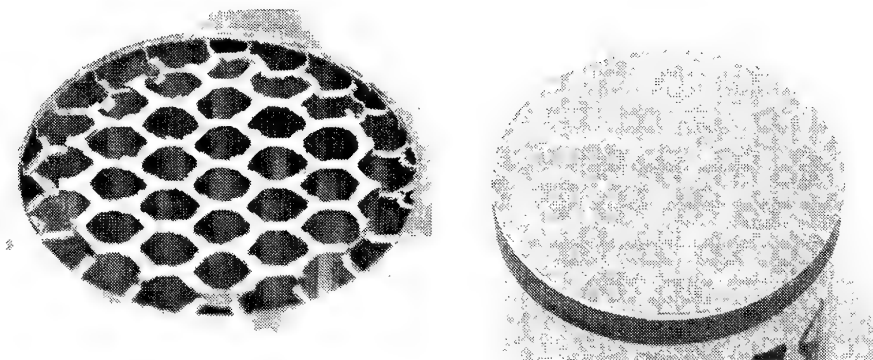
Figure 9 Failure surfaces resulting from tensile testing of the Untreated honeycomb and AF131-2 adhesive control specimen, indicating cohesive fillet bond failure.

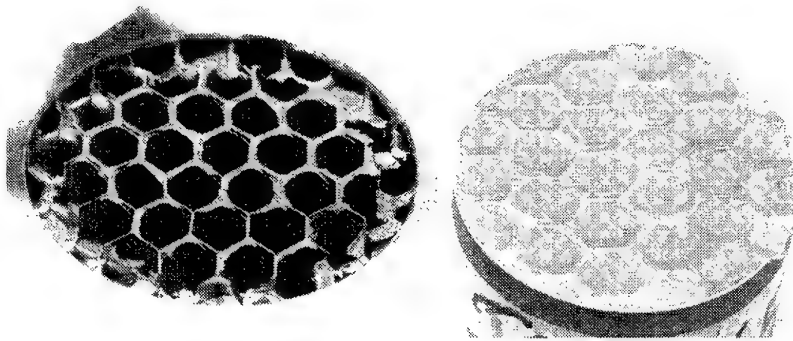
Figure 10 Failure surfaces resulting from tensile testing of the Untreated honeycomb and AF131-2 adhesive conditioned 30 days at 70°C/100%R.H., indicating fillet bond pull-out and cohesion failure.

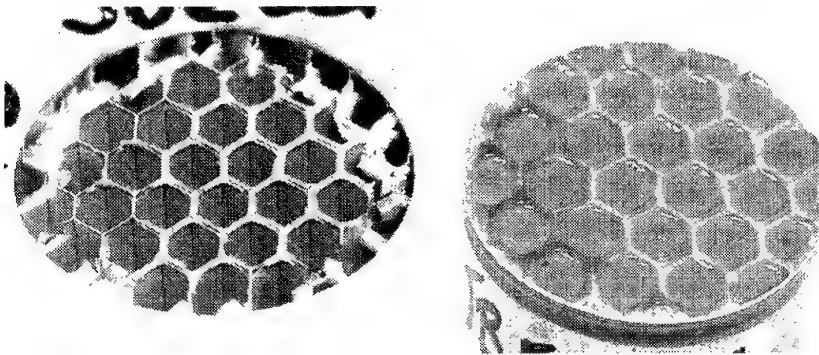
Figure 11 Failure surfaces resulting from tensile testing of the Untreated honeycomb and AF131-2 adhesive conditioned 150 days at 70°C/100%R.H., indicating fillet bond pull-out and cohesion failure.

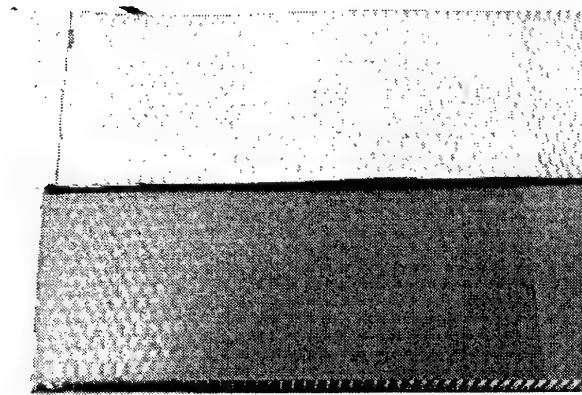
Figure 12 Failure surfaces resulting from peel testing of the Dura-Core honeycomb and JD Lincoln adhesive control specimen, indicating a mixture of cohesive failure and skin to adhesive failure.

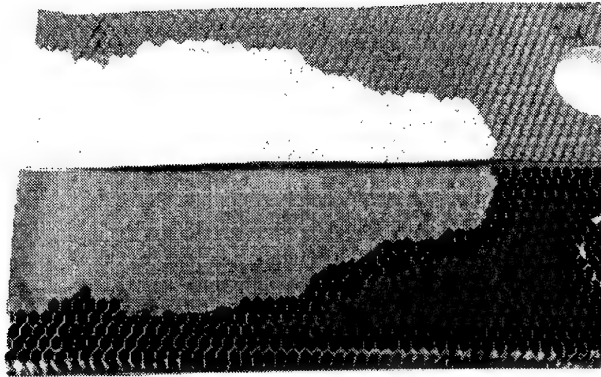
Figure 13 Failure surfaces resulting from peel testing of the Dura-Core honeycomb and JD Lincoln adhesive conditioned 30 days at 70°C/100% R.H., indicating fillet bond pull-out and skin to adhesive failure.

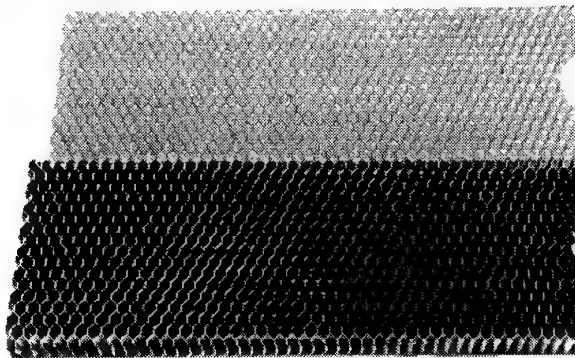
Figure 14 Failure surfaces resulting from peel testing of the Dura-Core honeycomb and JD Lincoln adhesive conditioned 150 days at 70°C/100% R.H., indicating fillet bond pull-out.

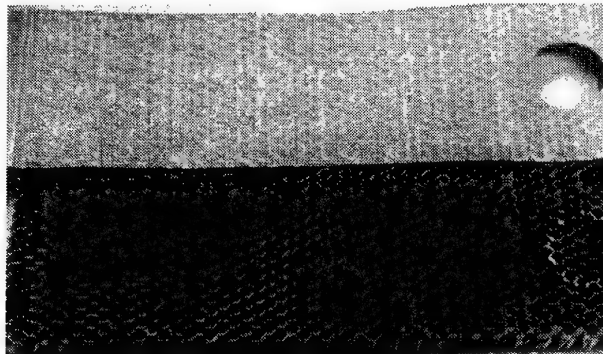
Figure 15 Failure surfaces resulting from peel testing of Untreated honeycomb and AF130-2 adhesive control specimen, indicating a mixture of cohesive failure and skin to adhesive failure.

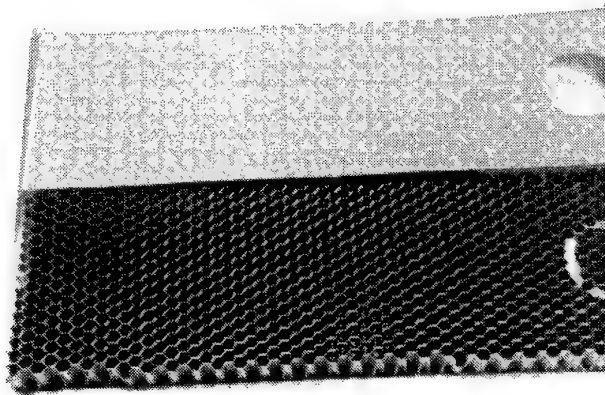
Figure 16 Failure surfaces resulting from peel testing of the Untreated honeycomb and AF130-2 adhesive conditioned 30 days at 70°C/100%R.H., indicating fillet bond pull-out.

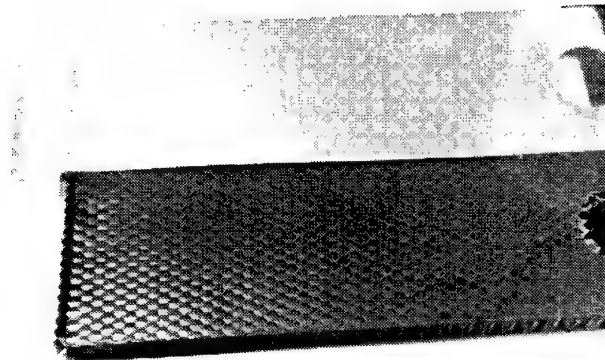
Figure 17 Failure surfaces resulting from peel testing of the Untreated honeycomb and AF130-2 adhesive conditioned 150 days at 70°C/100%R.H., indicating skin to adhesive disbond.

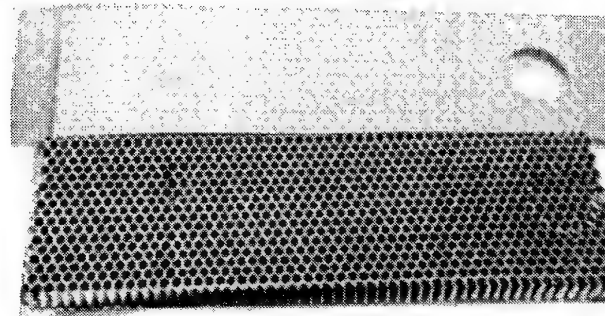
Figure 18 Failure surfaces resulting from peel testing of Untreated honeycomb and AF131-2 adhesive control specimen, indicating a mixture of cohesive failure and skin to adhesive failure.

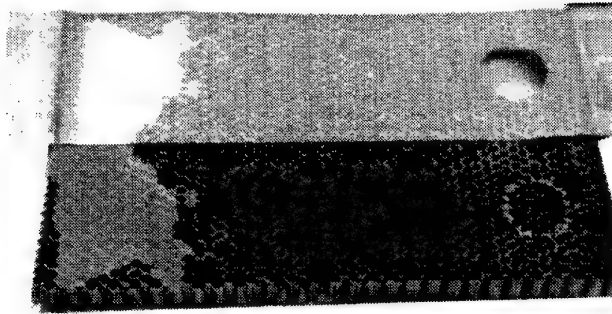
Figure 19 Failure surfaces resulting from peel testing of the Untreated honeycomb and AF131-2 adhesive conditioned 30 days at 70°C/100% R.H., indicating fillet bond pull-out, cohesion failure and skin adhesive disbond.

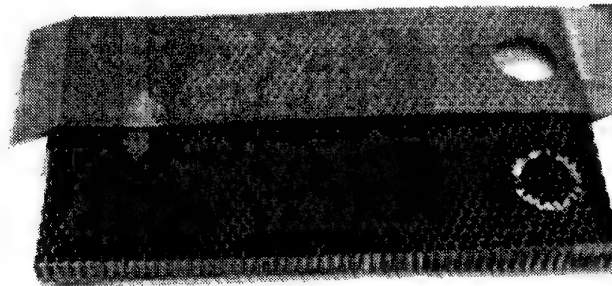
Figure 20 Failure surfaces resulting from peel testing of the Untreated honeycomb and AF131-2 adhesive conditioned 150 days at 70°C/100% R.H., indicating fillet bond pull-out and cohesion failure.

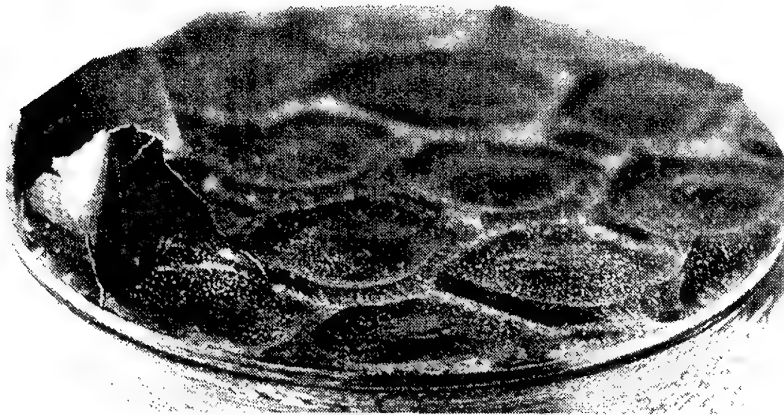
Figure 27 Failure surface of the portable adhesion test stub taken from the Stab-Tip after immersion in 50°C ionised water for 13 months, indicating regions of fillet bond pull-out.

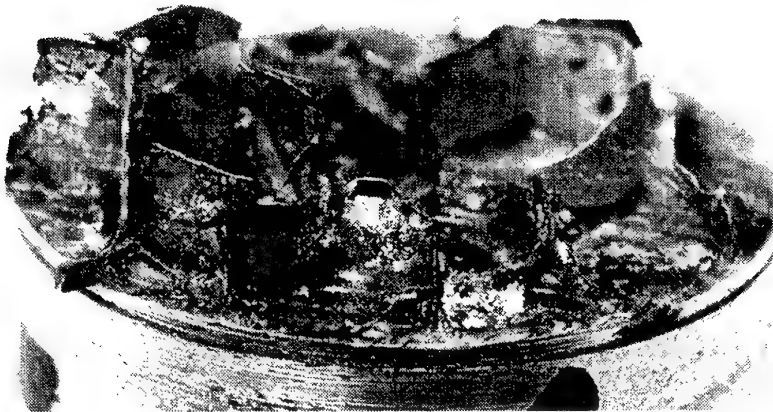
Figure 28 Failure surface of the portable adhesion test stub taken from the Stab-Tip after immersion in 50°C ionised water for 13 months, indicating regions of core corrosion leading to core fracture.

number of holes in the panel being present. In one location moisture ingress into the core had led to corrosion and consequent failure during tensile loading. However, in the majority of cases a mixture of cohesive fillet bond fracture and core fracture was observed. This mode is typically observed for the lighter gauge core material used to fabricate the Stab-Tip panel.

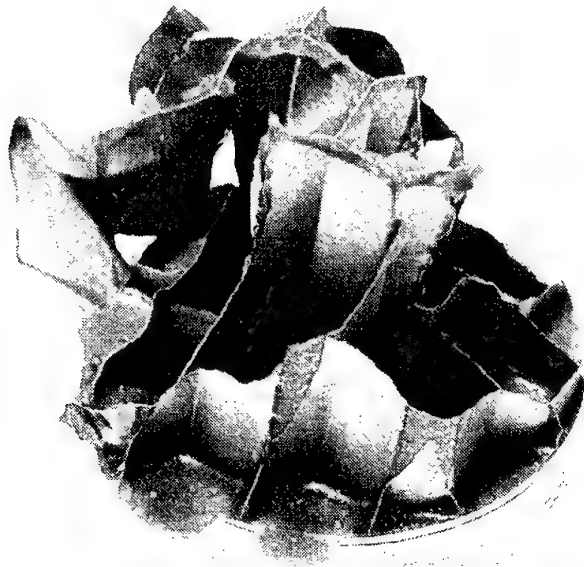
Figure 29 Failure surface of the portable adhesion test stub taken from the Stab-Tip prior to immersion in 50°C ionised water, indicating regions of honeycomb core fracture.

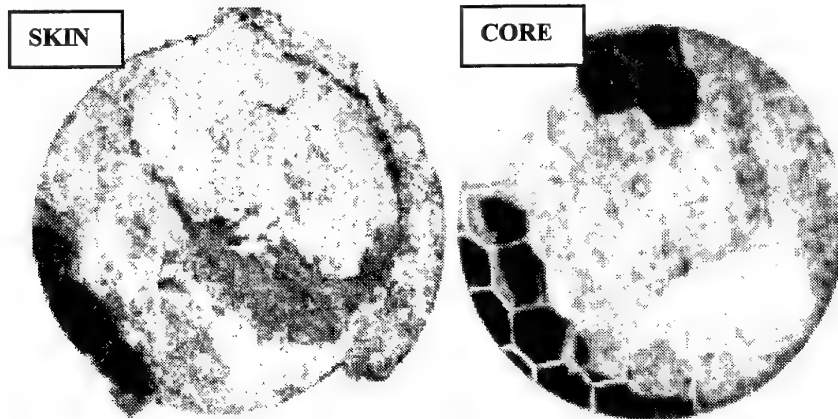
Figure 31 Failure surface images from the tensile test taken in location 4, refer Table 3, of the Stab-Tip Cap where skin to adhesive corrosion has degraded the honeycomb panel strength.

The Stab-Tip Cap indicated an area where significant strength reduction was caused by corrosion between the fillet adhesive and aluminium skin. This example of corrosion failure suggests that regions susceptible to moisture ingress on bonded panels should be considered carefully during routine aircraft maintenance and inspection. NDI of the Stab-Tip Cap also suggested that the Tap-Hammer test is potentially difficult to apply in a consistent and reliable manner to identify disbanded panel regions. The area identified by the Tap-Hammer test indicated Tensile strength values were normal. The Stab-Tip Cap inspection also highlighted the deficiency in the use of injection repairs. The reduction in tensile strength and observation of the failure mode suggested that the injected potting compound had not adequately wetted the core and skin, leading to a weak adhesive bond. The low strength value recorded also suggested that strength of the potting compound was low, as indicated by regions where the potting compound had fractured cohesively.

- 2) Due to the poor durability of honeycomb sandwich panels that have been rebuilt or repaired using either AF-130-2, AF131-2 or JD Lincoln adhesive and Alcore Duracore or Untreated honeycomb, special attention should be given to ensuring perimeters of panels are carefully sealed to prevent any moisture ingress.

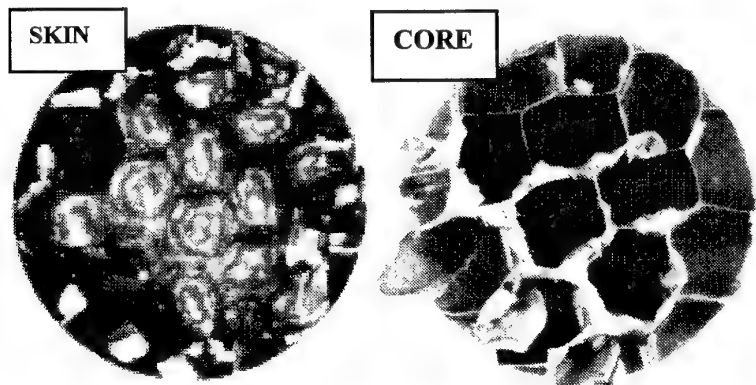
Figure 32 Failure surface images from the tensile test taken in location 3, refer Table 3, of the Sta-Tip Cap, where an ineffective injection repair has degraded the honeycomb panel strength.

- 3) During inspection and maintenance, regions of panels containing old or existing injection repairs should be carefully inspected for potential disbonds and corrosion.
